New York State Department of Transportation

Yellow Flag NB22CTW009

BIN: 1065318

Location: Span 182, Girder G1 at Pier 182.

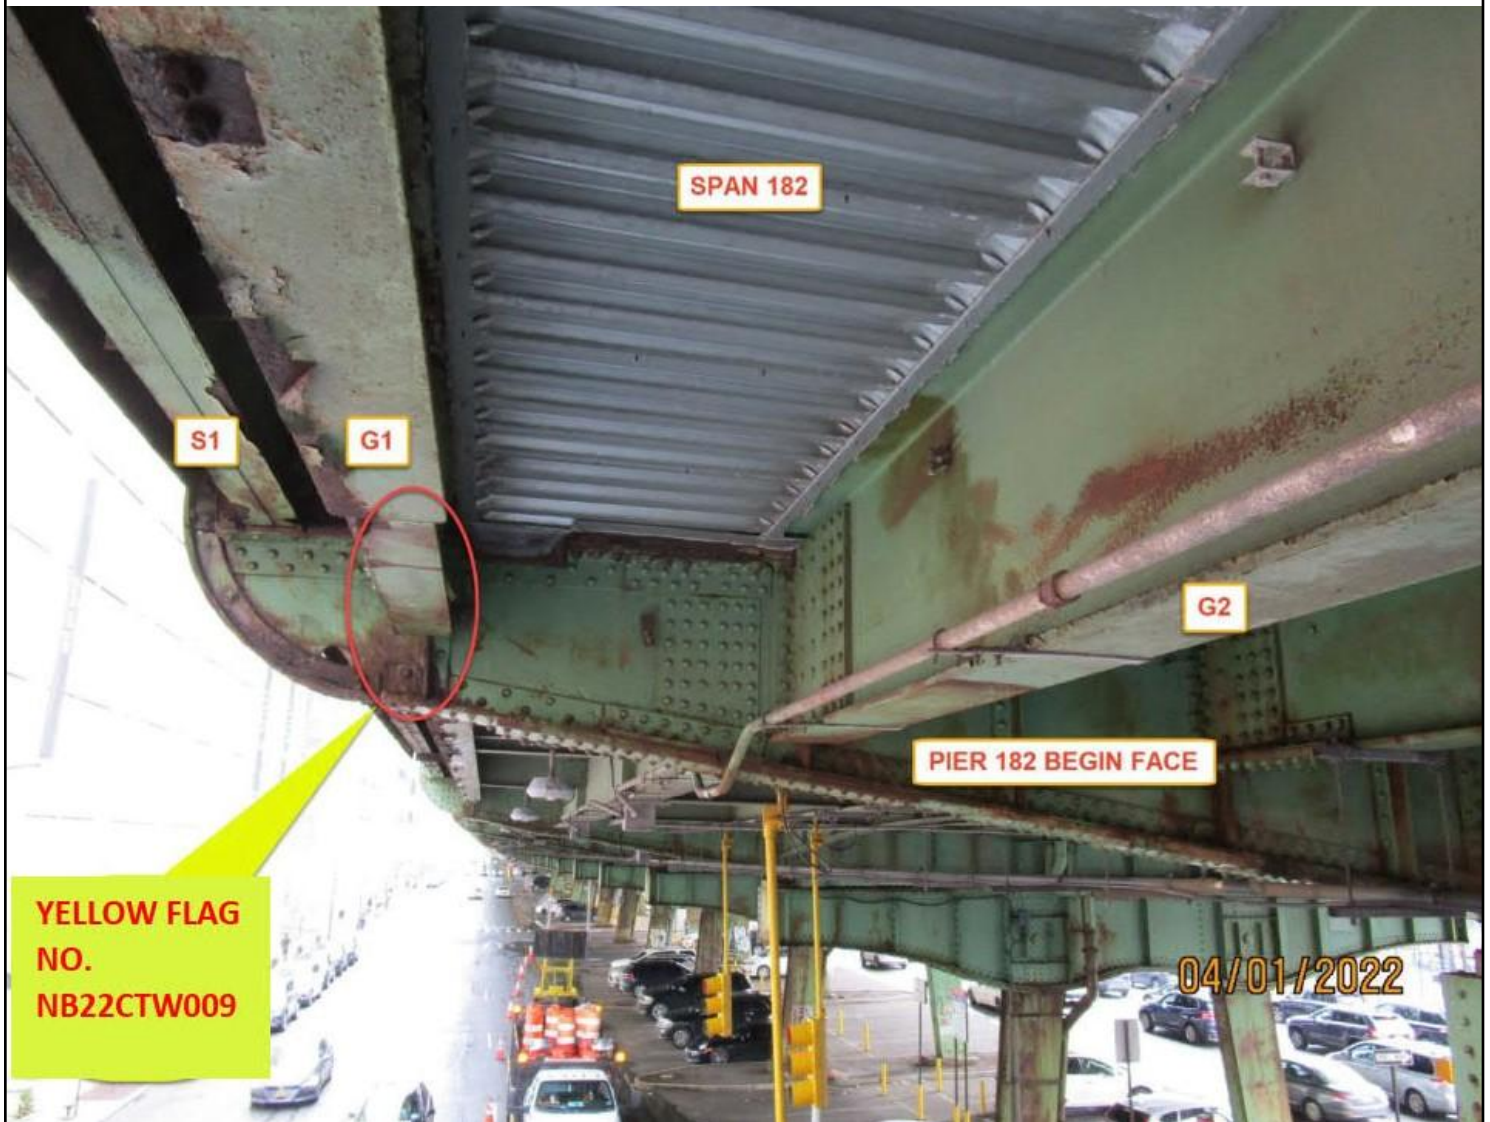
Photo Number: 1

Attachment Description: General view of girder layout and flagged location. Looking end.

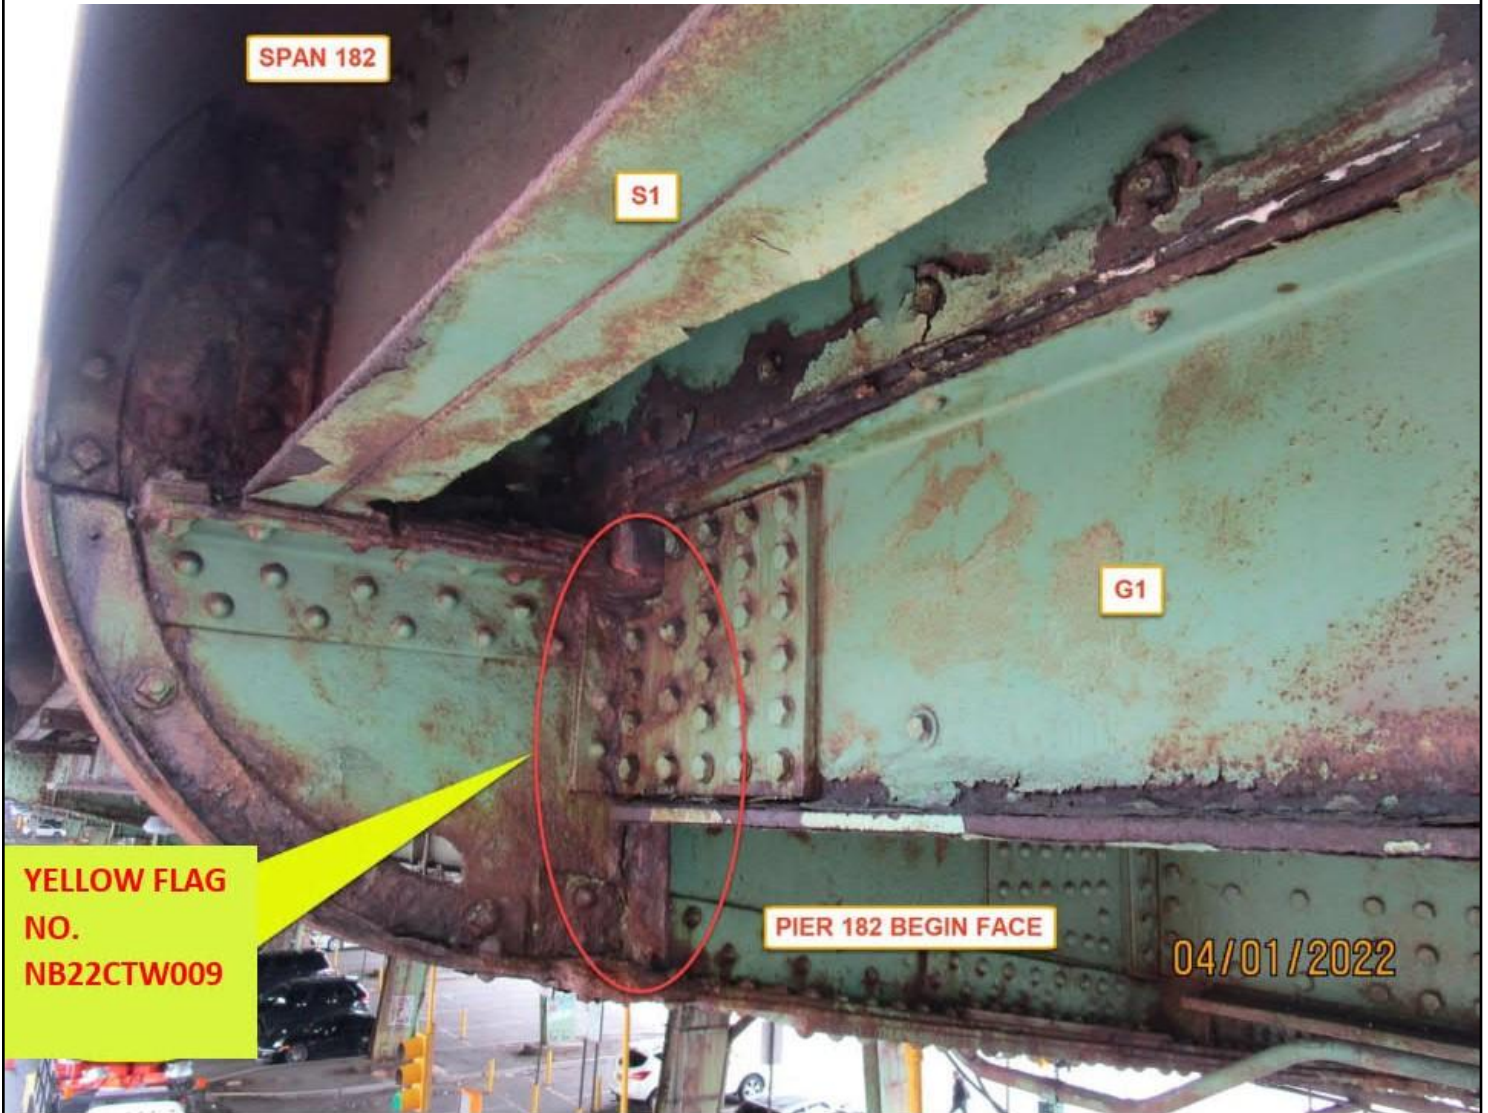
Photo Number: 2

1. The stiffener connection angle at the right side has a 2" H x 2" W corrosion hole below the bottom flange of Girder G1 and a second corrosion hole at the base measuring 2" x 1-1/2". (Both holes with slight changes from the previous inspection).
2. The adjacent Stringer (left) S1, acts as a support for the railing and curb area above and has heavy corrosion at the right-side connection angle with up to 3/16" section loss for 3" long. In addition, the bottom flange right side angle has a 4" x 2-3/4" corrosion hole. There is no significant change in the condition since the previous inspection.
3. The adjacent Girder G2 (right) S2 has repair plates in good condition.
4. A double left lane closure on 3rd Avenue Westbound with shadow vehicle and a 35' bucket truck is required to access the flagged location.

Attachment Description: General view of vertical crack at upper fillet of clip connection angle and corrosion holes at lower section of stiffener connection angle. Looking end right.

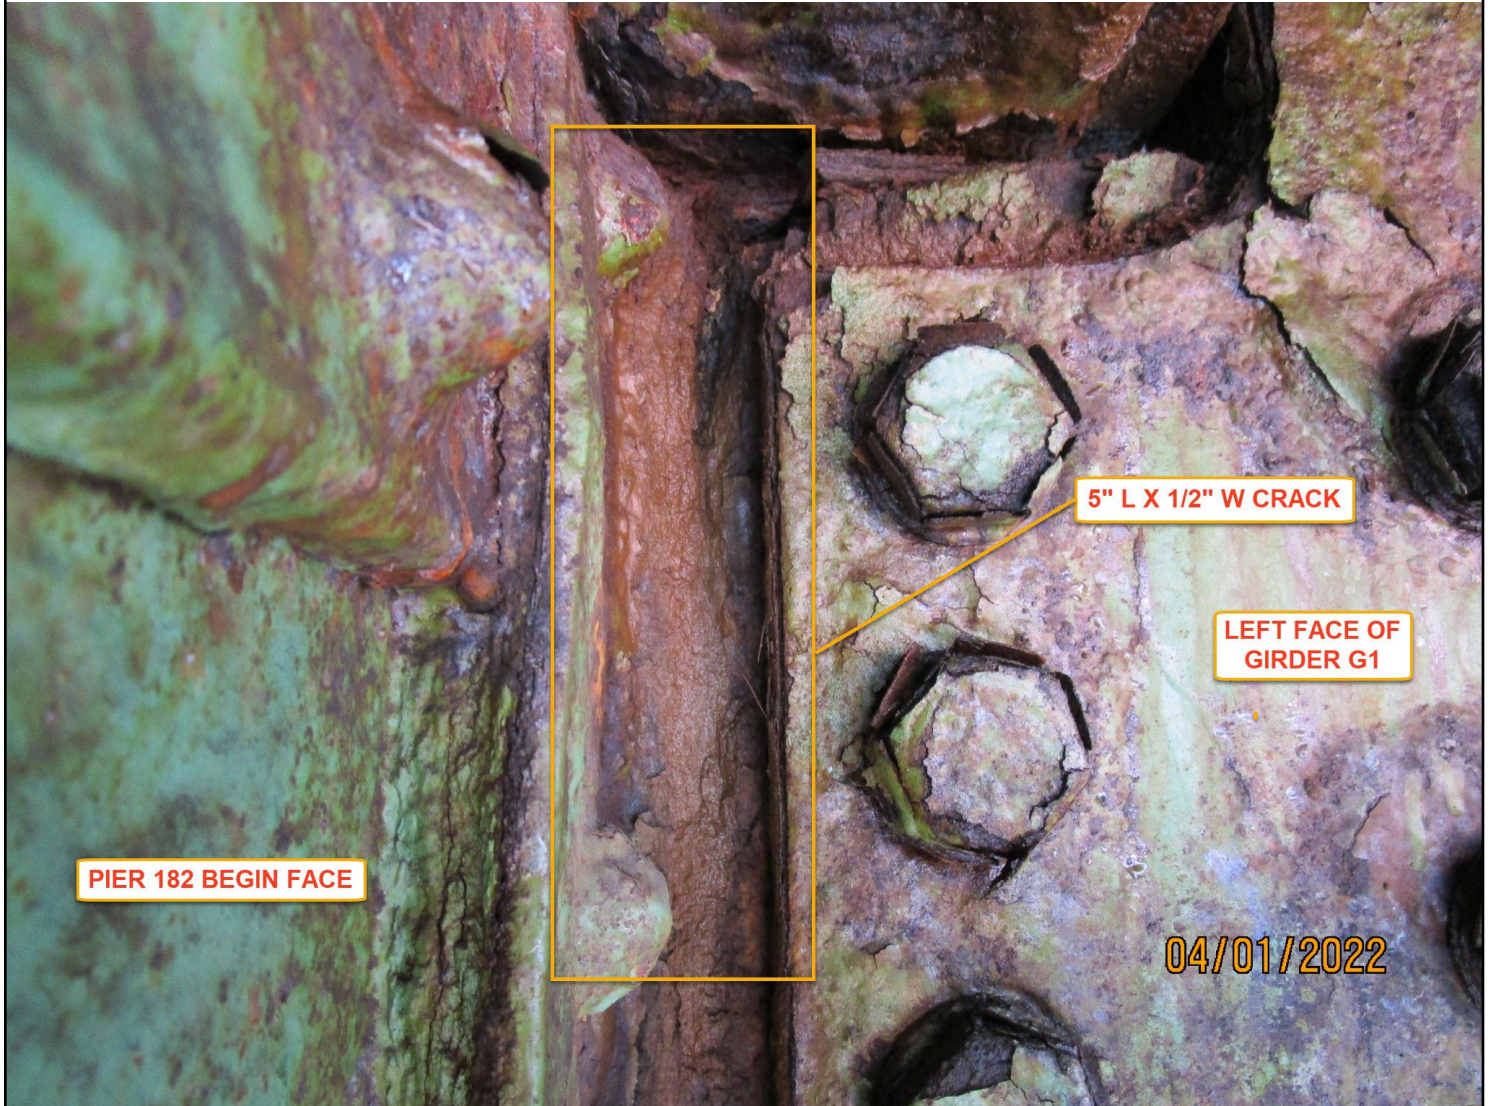
Photo Number: 3

Description: The left clip connection angle of Girder G1 connection to pier cap at Pier 182 exhibits a 5" long vertical corrosion crack x 1/2" wide at the upper fillet section (deterioration induced cracking). This condition has not changed since the last inspection.

Attachment Description: Close up view of 5" L x 1/2" wide corrosion crack at upper fillet of left side clip connection angle at connection to Pier Cap. Looking right.

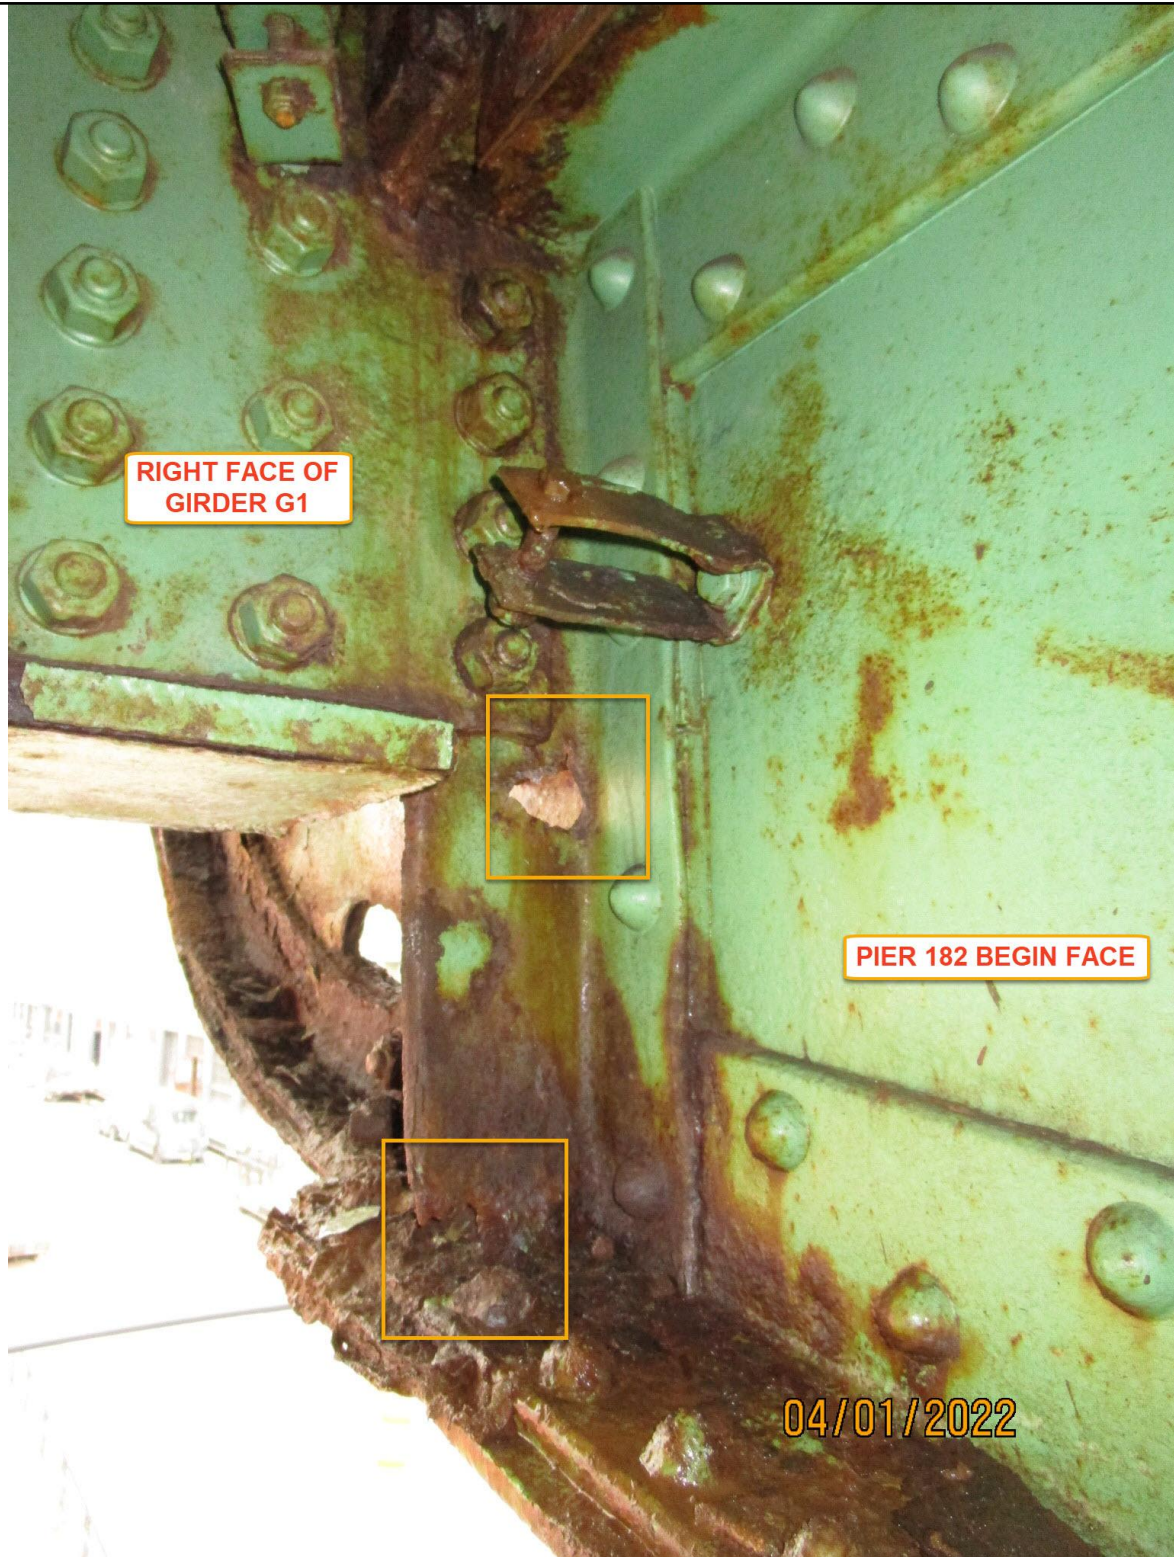
Photo Number: 4

Attachment Description: Upper section of stiffener connection angle at Girder G1 at Pier Cap connection is in good condition. The lower section exhibits corrosion holes. Looking end left.

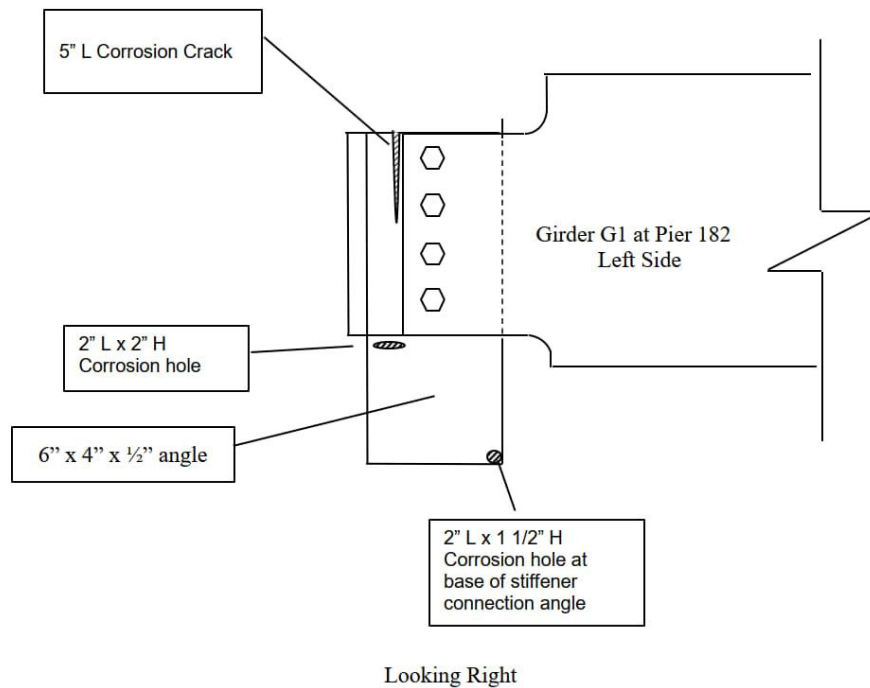
Photo Number: 5

Attachment Description: Span 182 G1 at Pier 182 Sketch

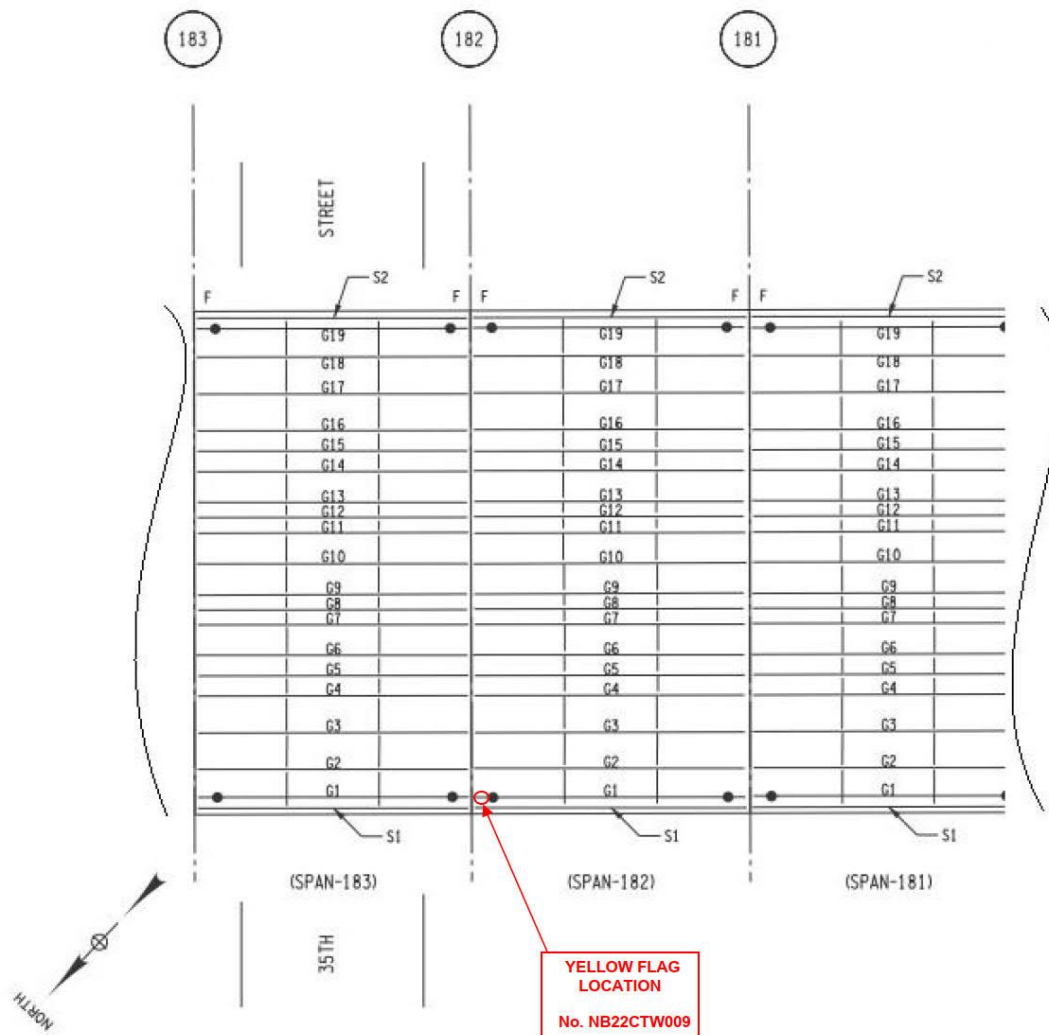
Photo Number: 6

Attachment Description: Span 182 G1 at Pier 182 Framing Plan
